SERVICE INSTRUCTIONS

*ET150 - ET200 (Same procedure for alarm equivalent models)

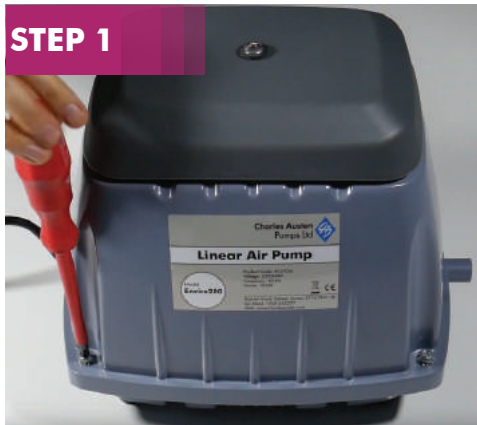
STEP 1

To start, unplug the pump from the mains. Unscrew and remove the cover from the air pump.

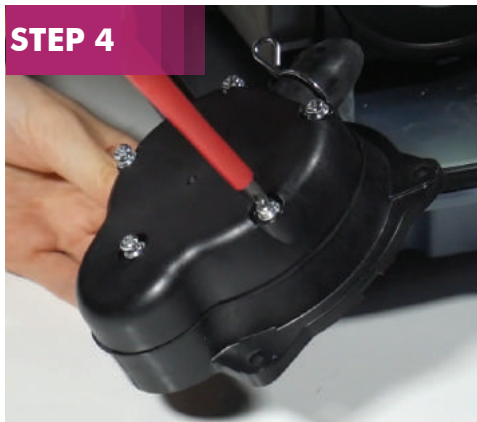
STEP 4

Unscrew the chamber block and pull it apart.

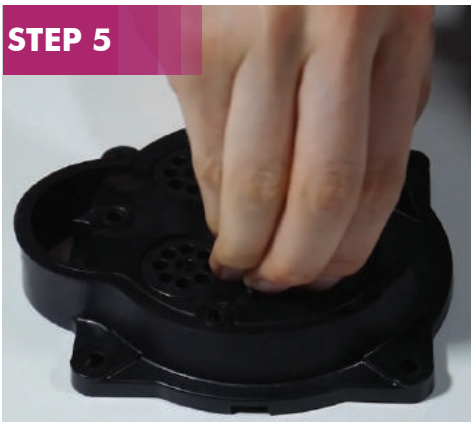
STEP 5

Remove the valves from the chamber block, take note of the valve formation.

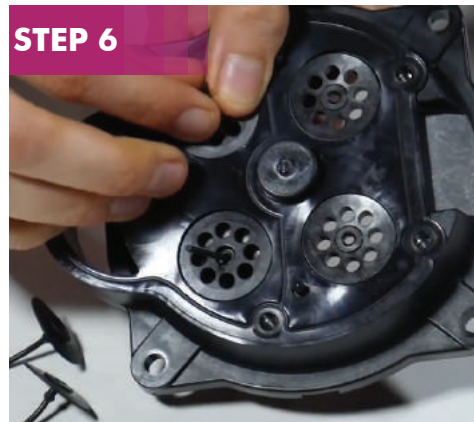
STEP 6

Pull the new valves through, you should hear a 'snap' sound once secured in place.

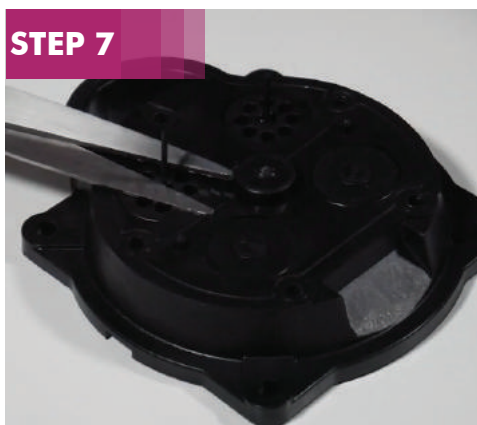
STEP 7

Cut the excess rubber off from the valves and discard.

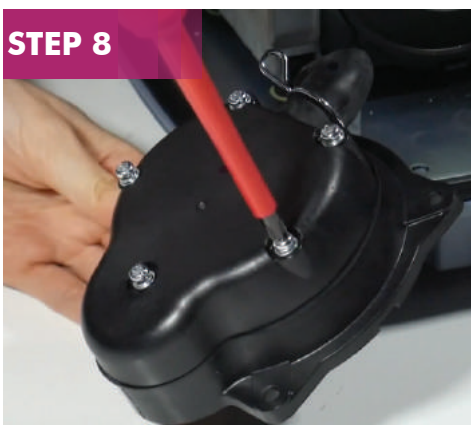
STEP 8

Screw the chamber block back together ensuring the rubber seal between them lined up properly. Repeat this process on the opposite side of the pump.

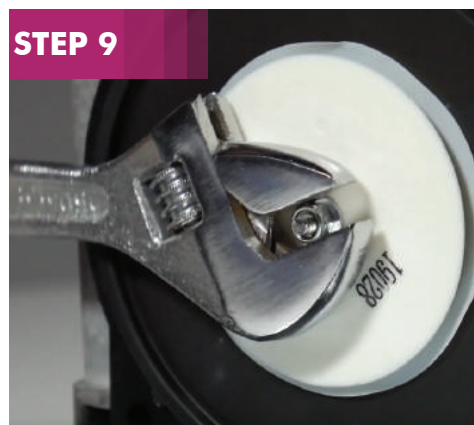
STEP 9

Undo the bolt from the diaphragm.

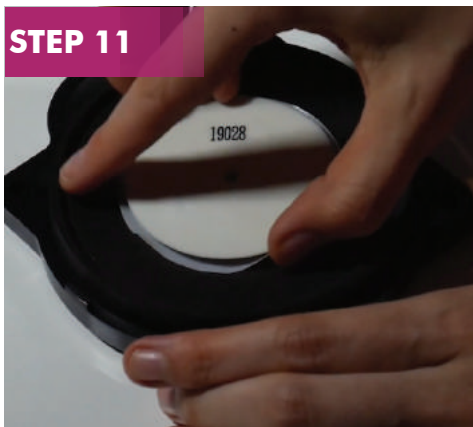
STEP 11

Replace the worn diaphragm with the new one provided in your service kit. Make sure the diaphragm has been pushed into the grooves of the diaphragm frame. Repeat this process on the opposite side of the pump.

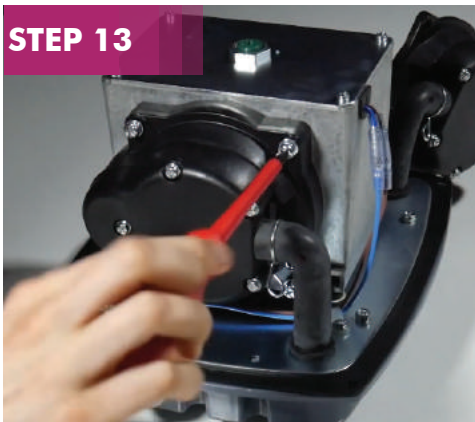
STEP 13

Connect the chamber block and diaphragm together and screw back into place. Repeat on the opposite side of the pump.

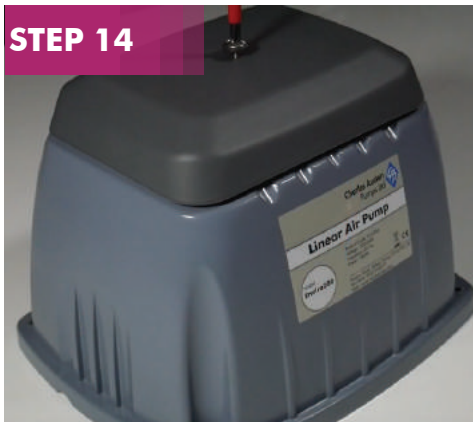
STEP 14

To change the filter unscrew the pump lid.

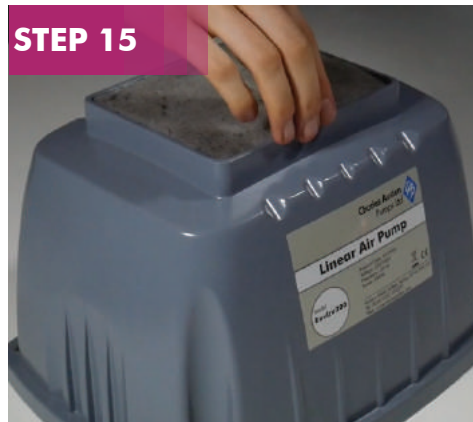
STEP 15

Remove the dirty filter and clean away any dust or dirt that has been collected.

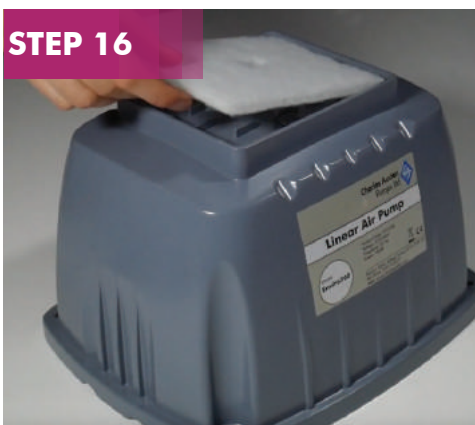
STEP 16

Replace the dirty filter with the new one provided in our service kit.

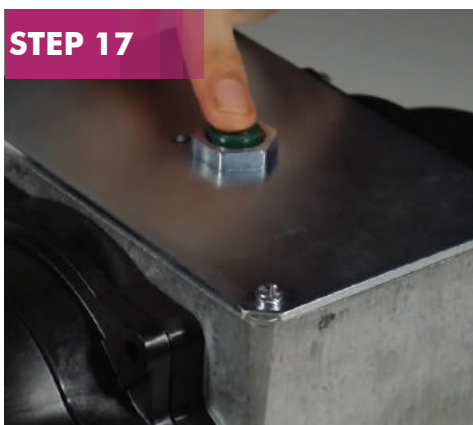
STEP 17

Note: Before screwing the pump back together ensure the safety switch button is pushed down. If this step is not completed then the pump will not run.

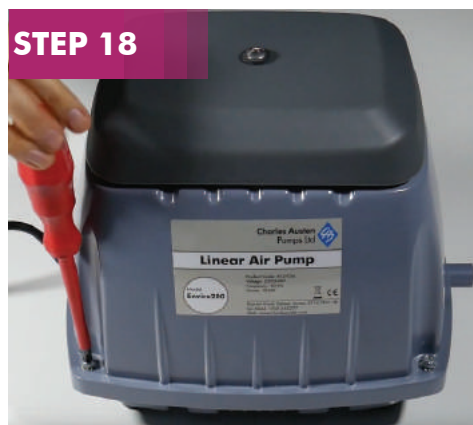
STEP 18

Finally, put housing back together ensuring the screws are secured down properly.
